## Chapter 9

# FIRE BEHAVIOR IN WORLD TRADE CENTER 2

### 9.1 INTRODUCTION

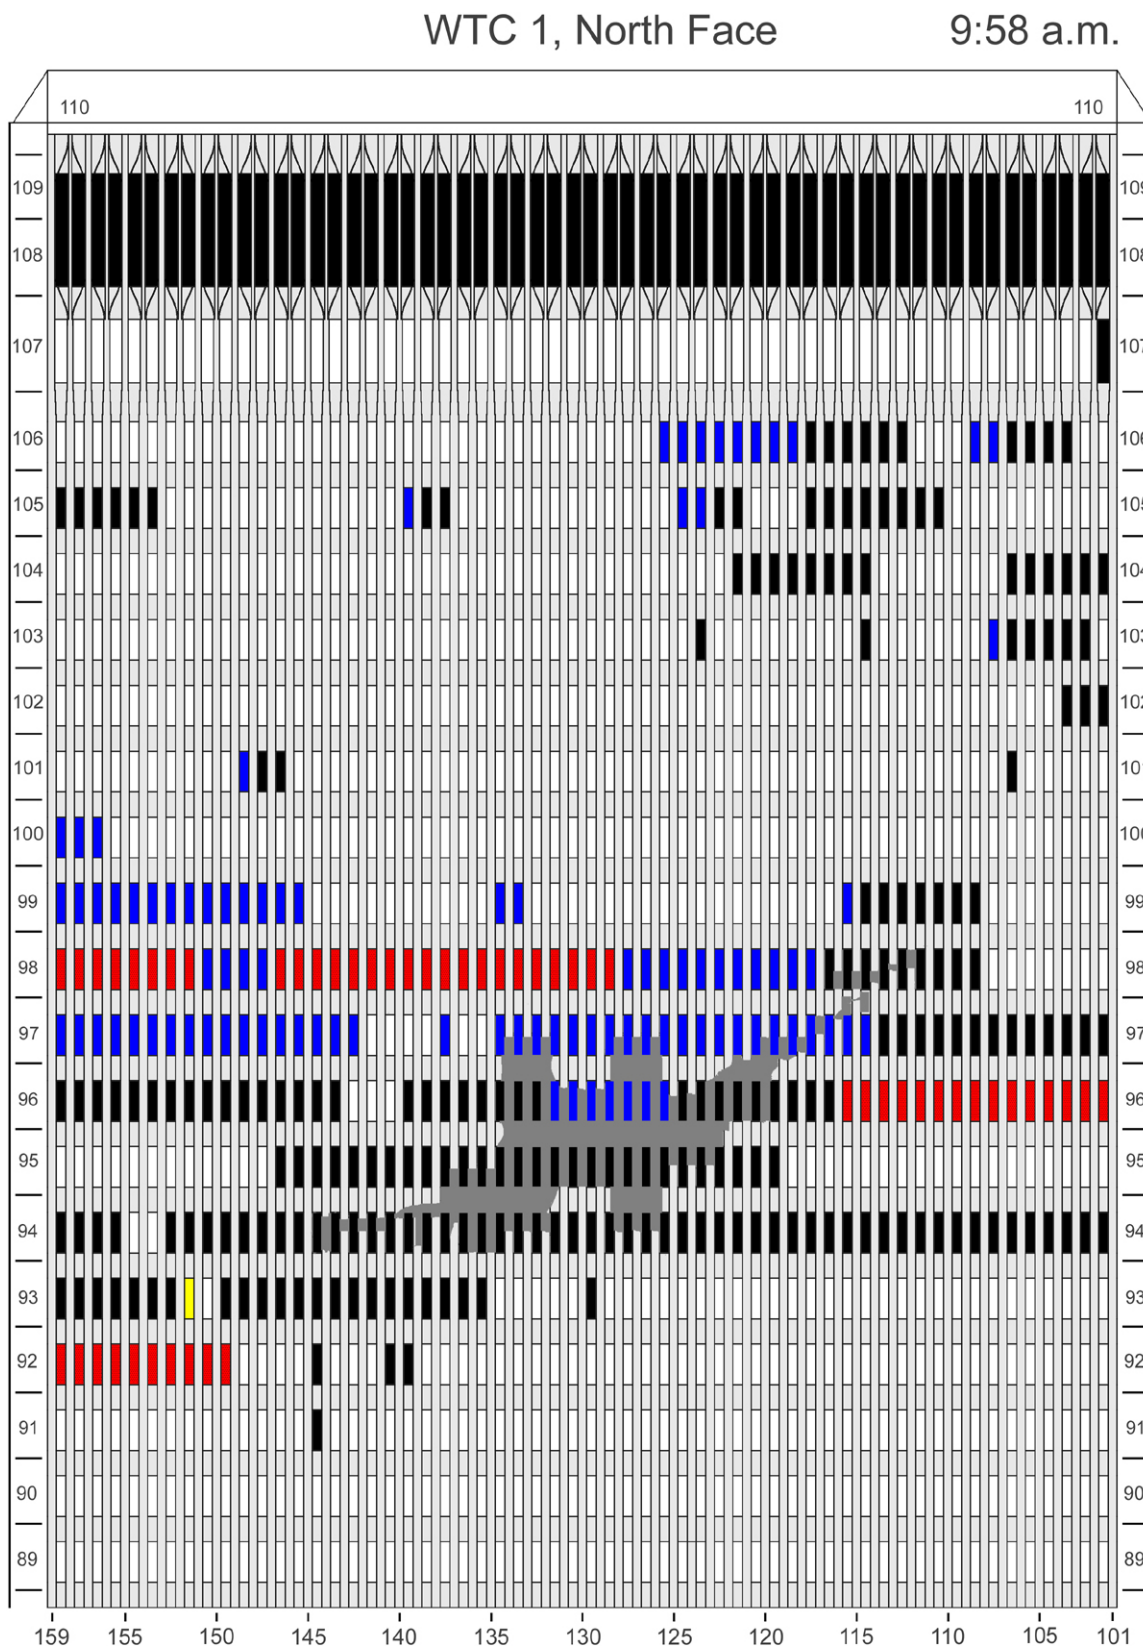
**Figure C-43. Diagram of the north face of WTC 1 for floors 89 to 110 at 9:58 a.m. showing the condition of windows and locations of fires.**

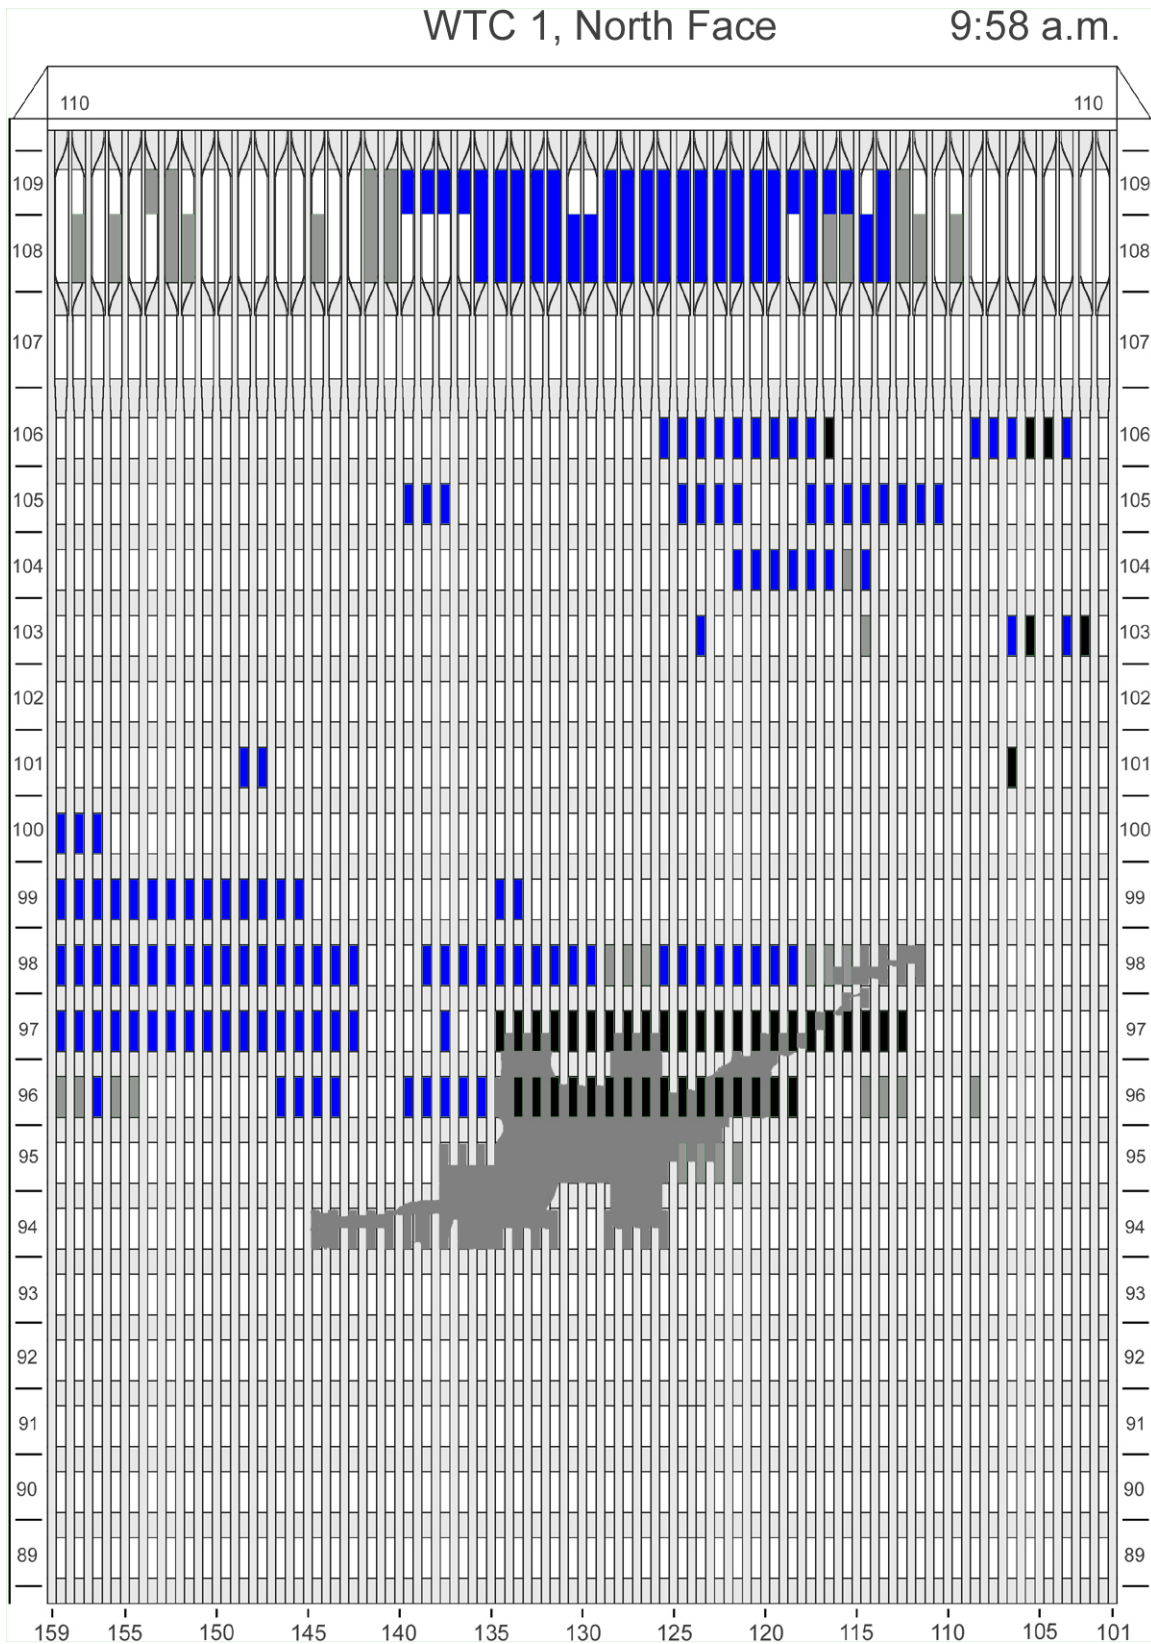
**Figure C-44. Diagram of the north face of WTC 1 for floors 89 to 110 at 9:58 a.m. showing windows where smoke was observed and those that were hidden from view.**

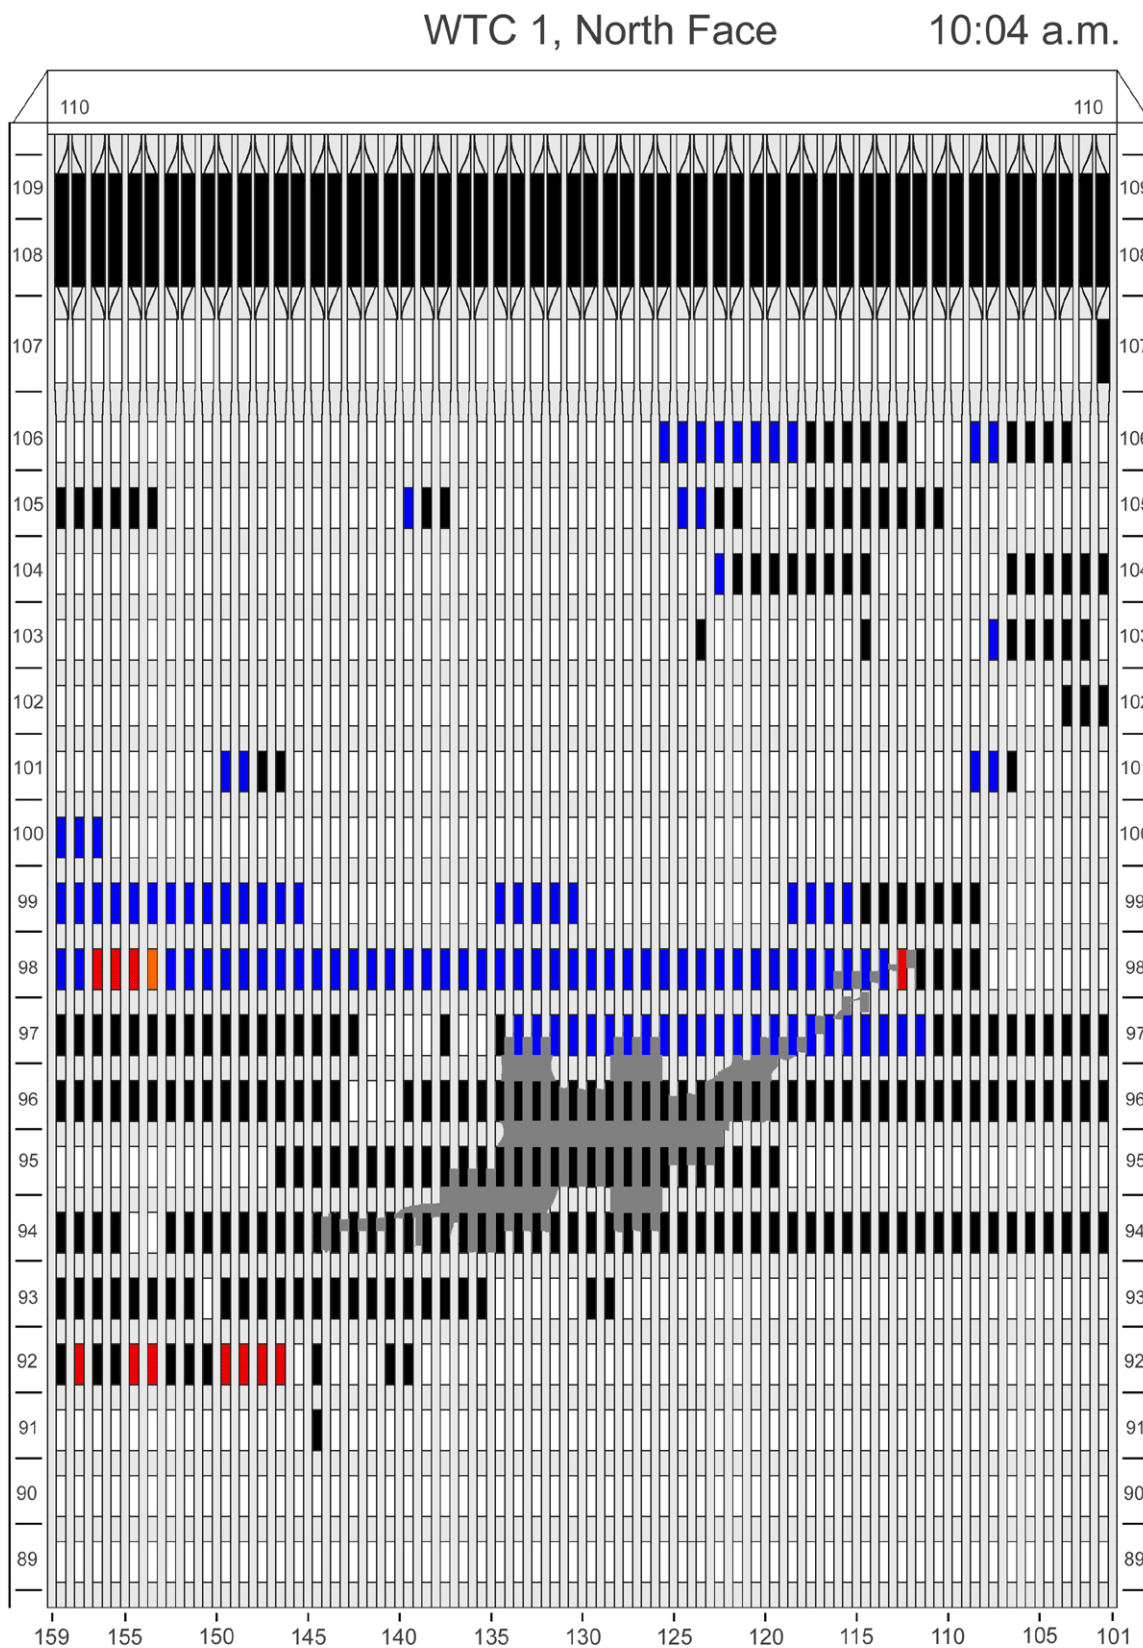
**Figure C-45. Diagram of the north face of WTC 1 for floors 89 to 110 at 10:04 a.m. showing the condition of windows and locations of fires.**

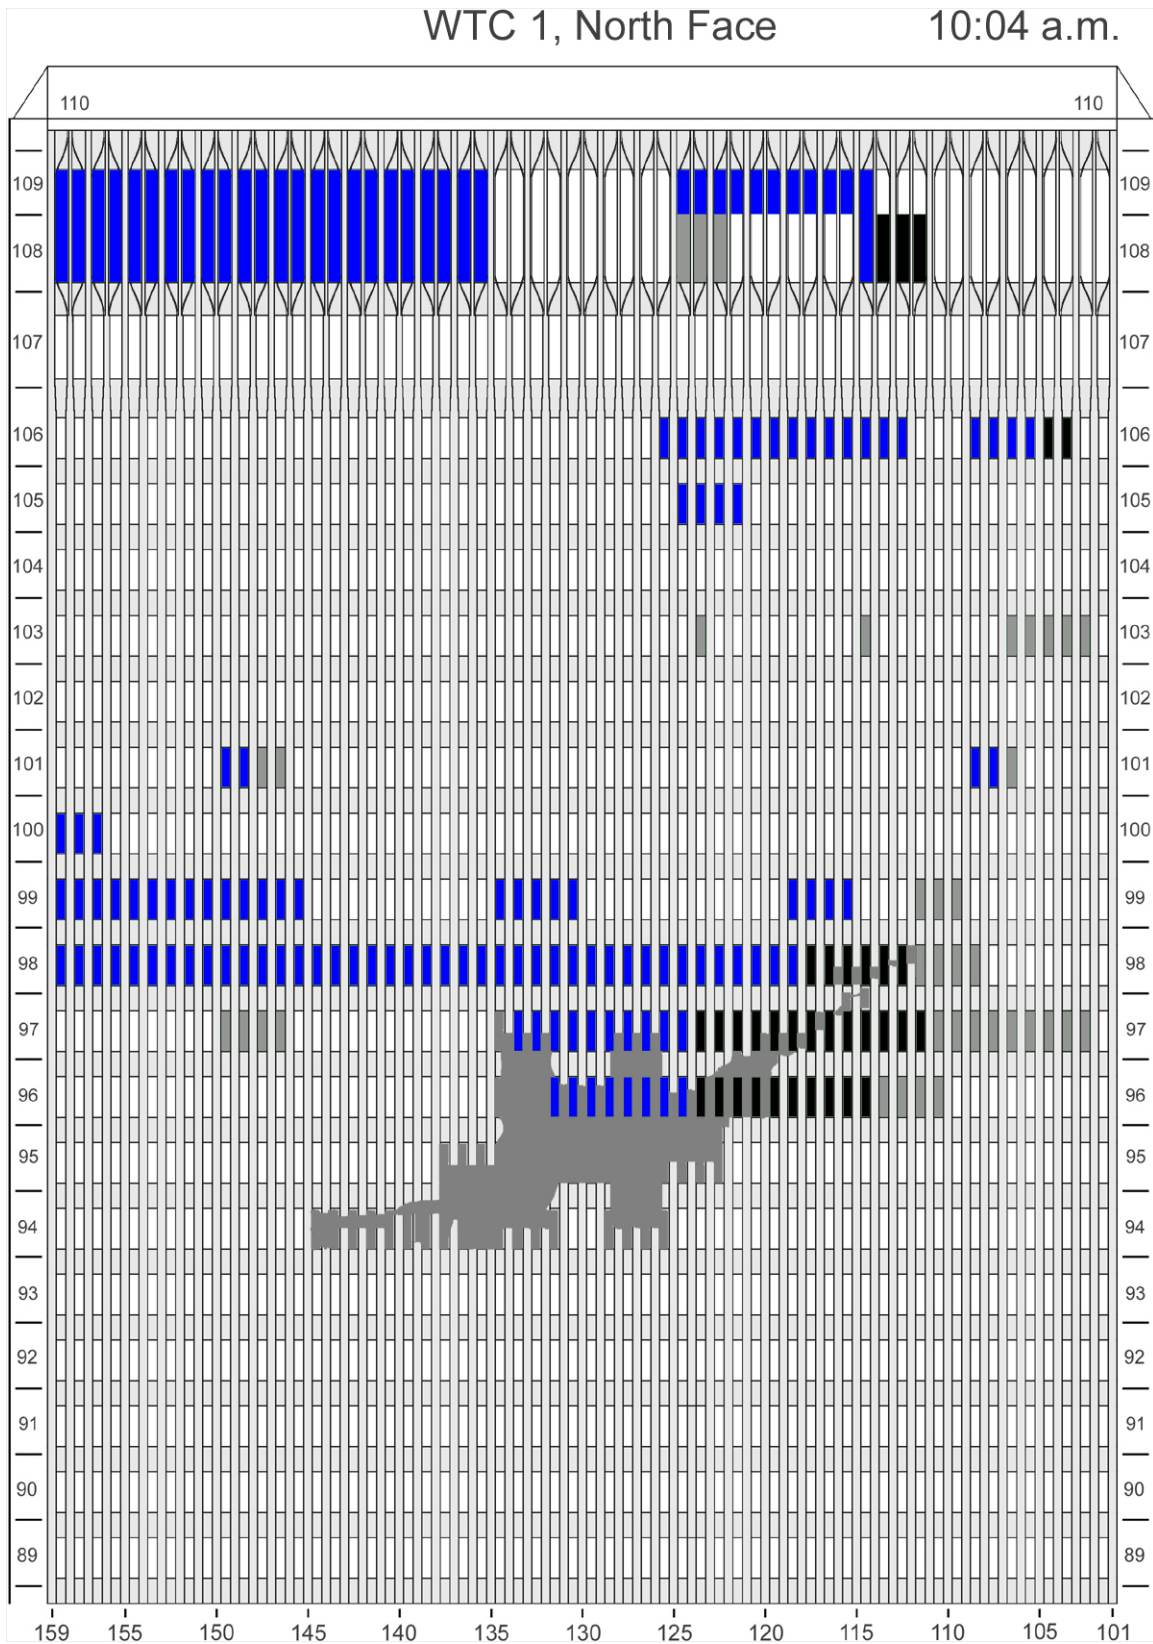
**Figure C-46. Diagram of the north face of WTC 1 for floors 89 to 110 at 10:04 a.m. showing windows where smoke was observed and those that were hidden from view.**

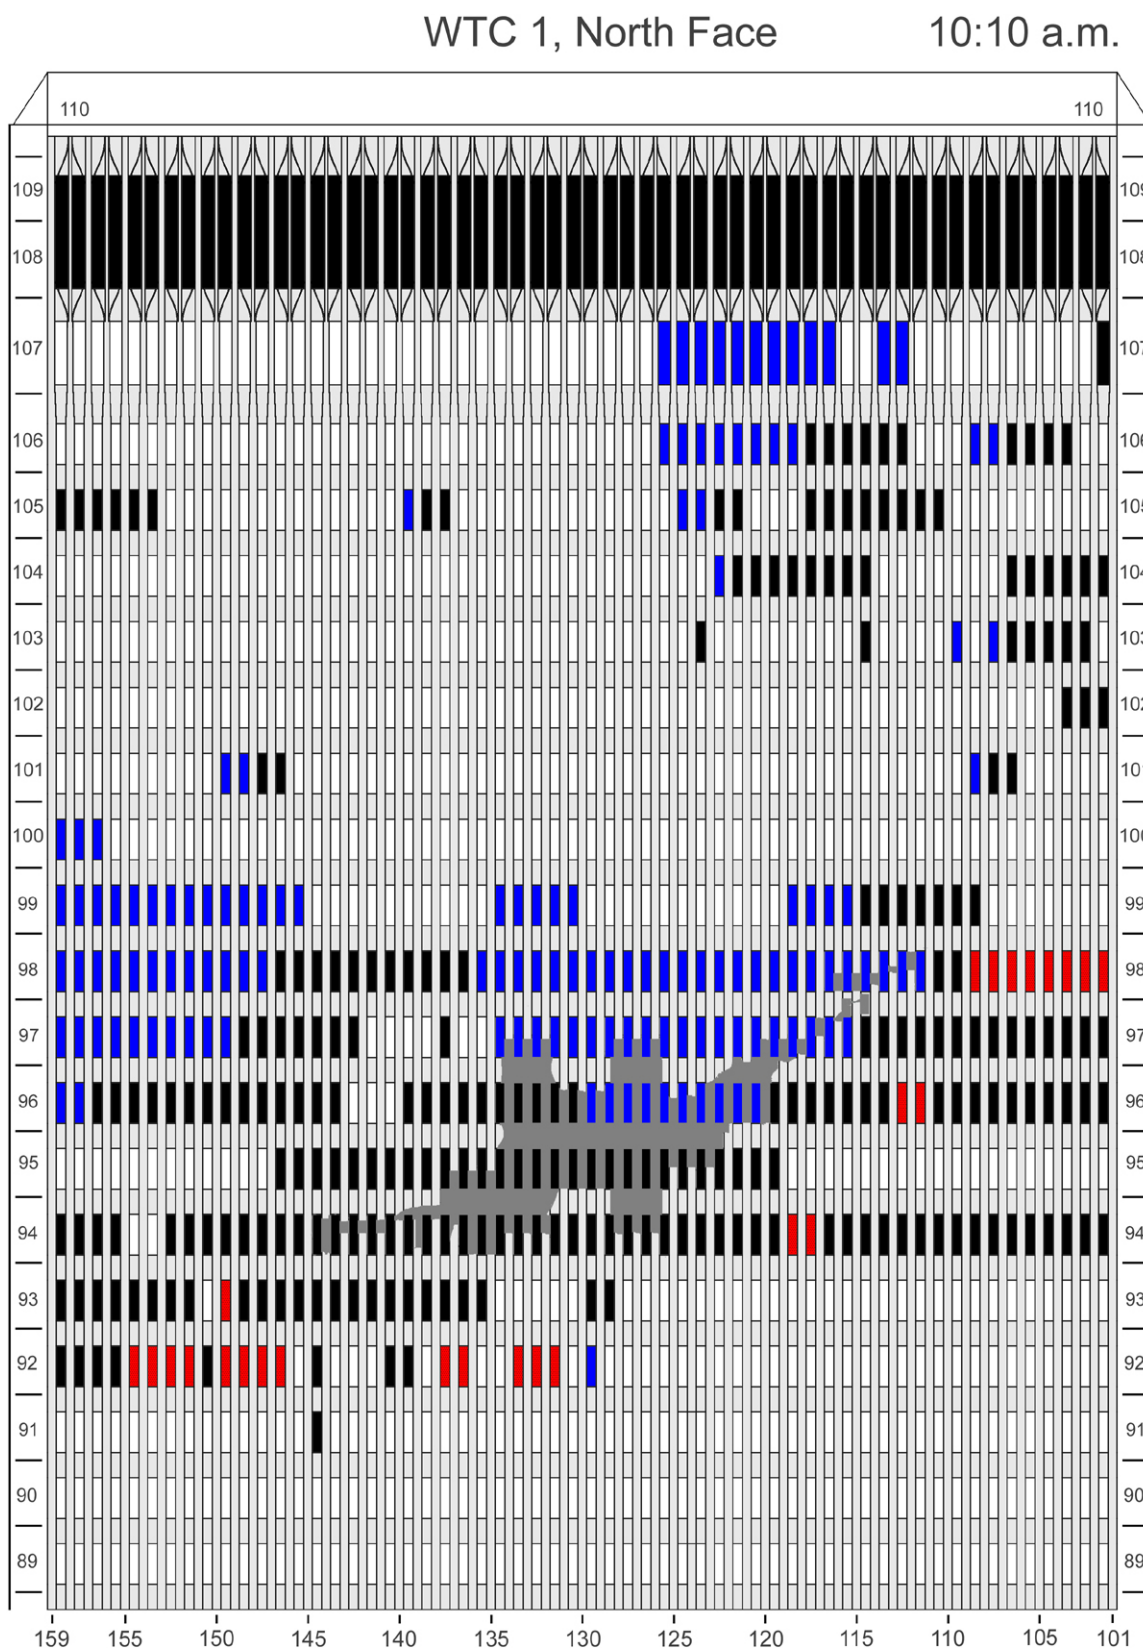
**Figure C-47. Diagram of the north face of WTC 1 for floors 89 to 110 at 10:10 a.m. showing the condition of windows and locations of fires.**

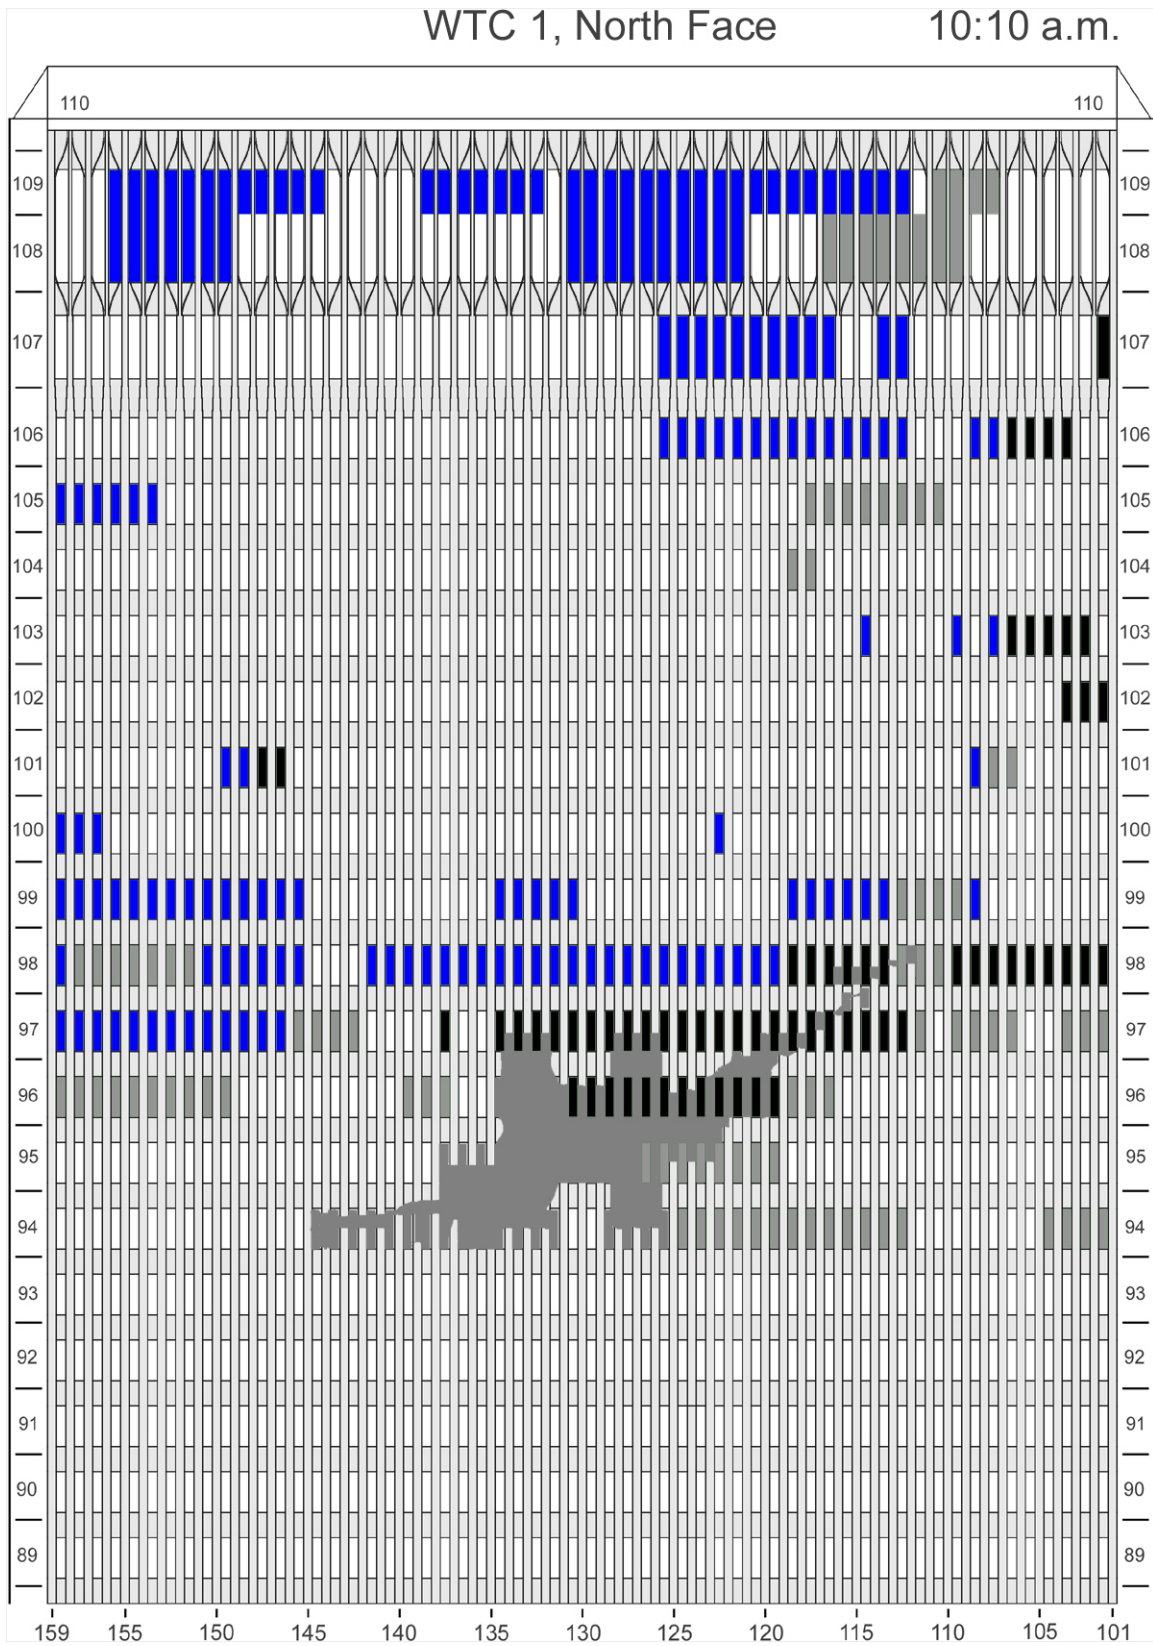
**Figure C- 48. Diagram of the north face of WTC 1 for floors 89 to 110 at 10:10 a.m. showing windows where smoke was observed and those that were hidden from view.**

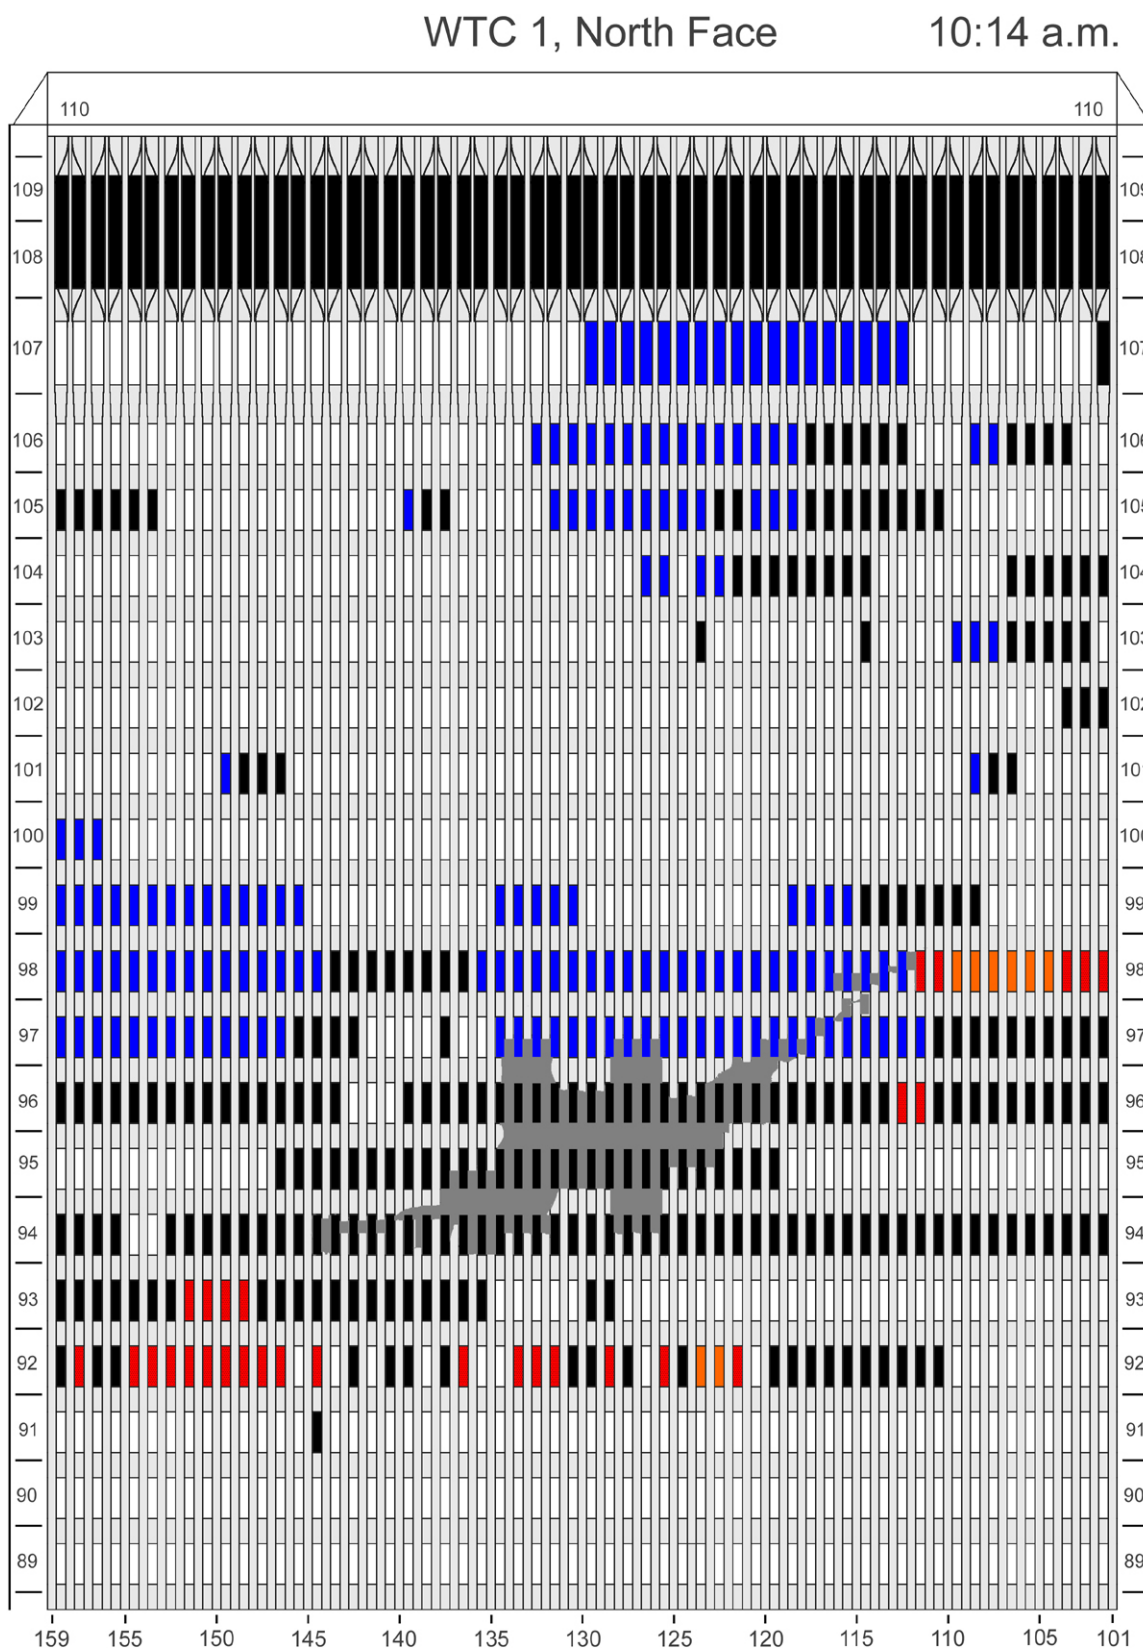
**Figure C-49. Diagram of the north face of WTC 1 for floors 89 to 110 at 10:14 a.m. showing the condition of windows and locations of fires.**

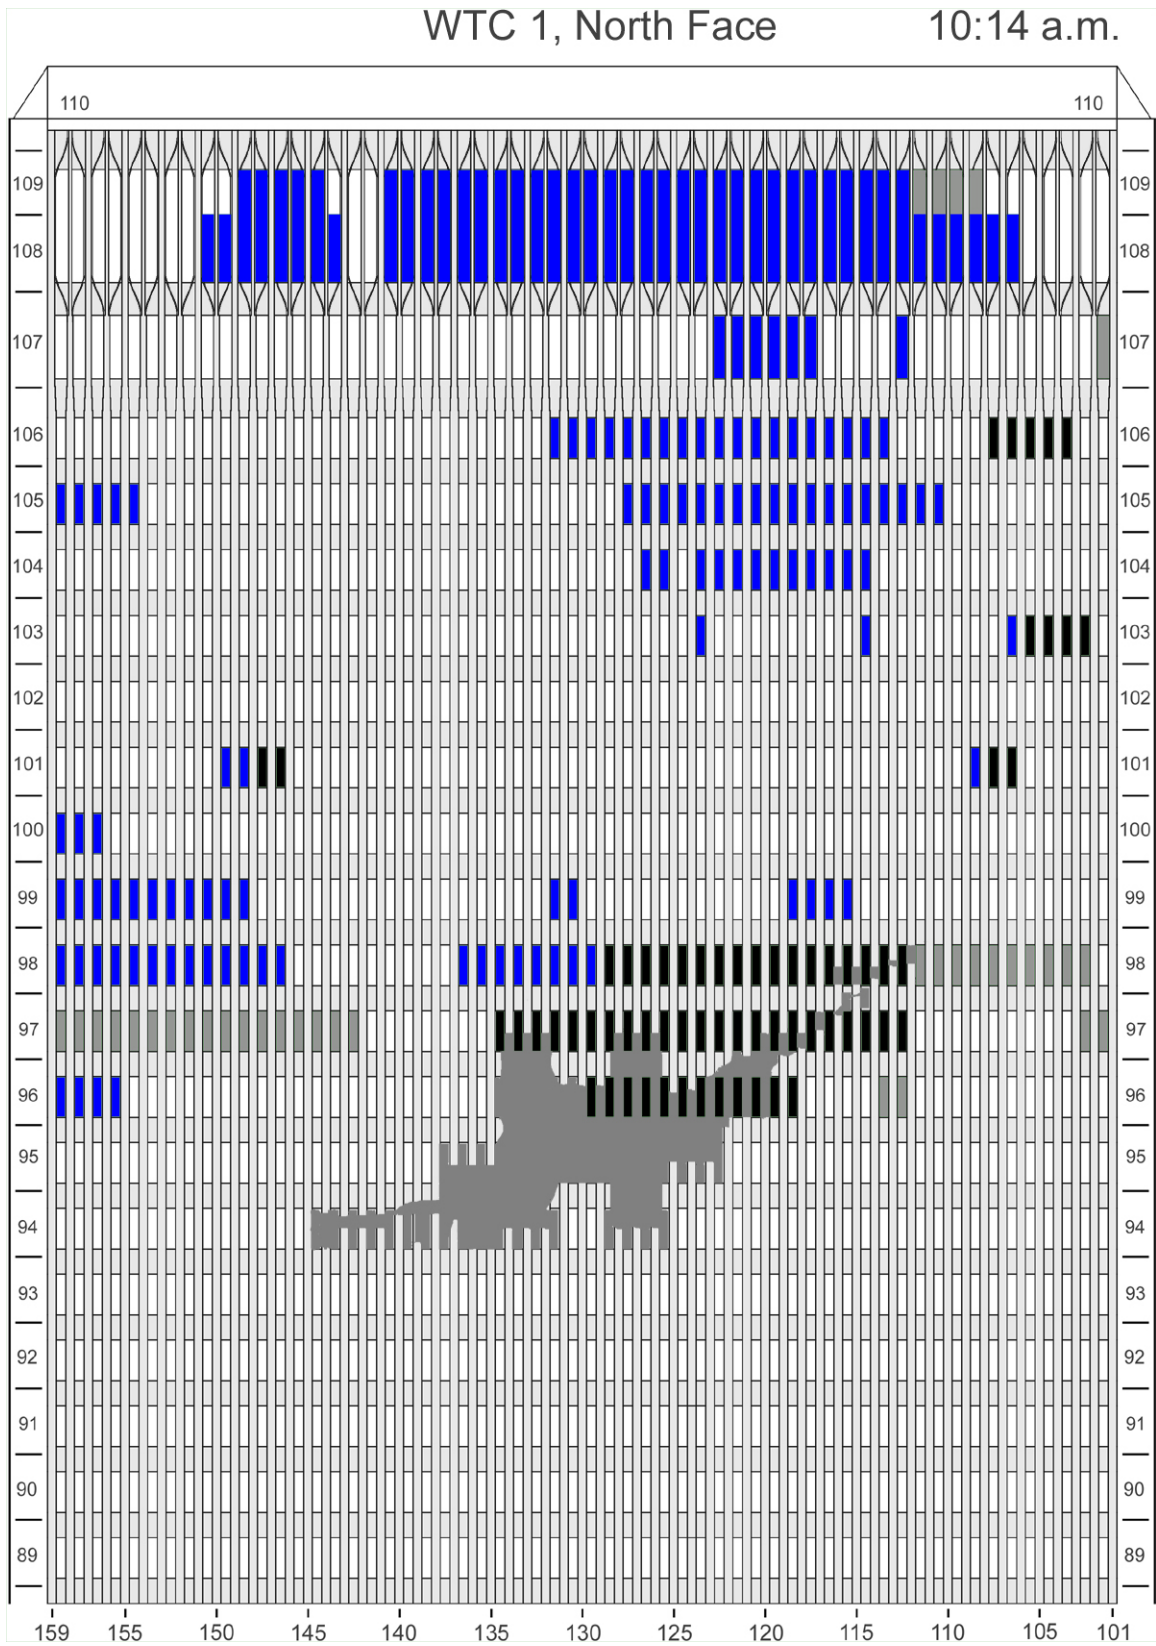
**Figure C-50. Diagram of the north face of WTC 1 for floors 89 to 110 at 10:14 a.m. showing windows where smoke was observed and those that were hidden from view.**

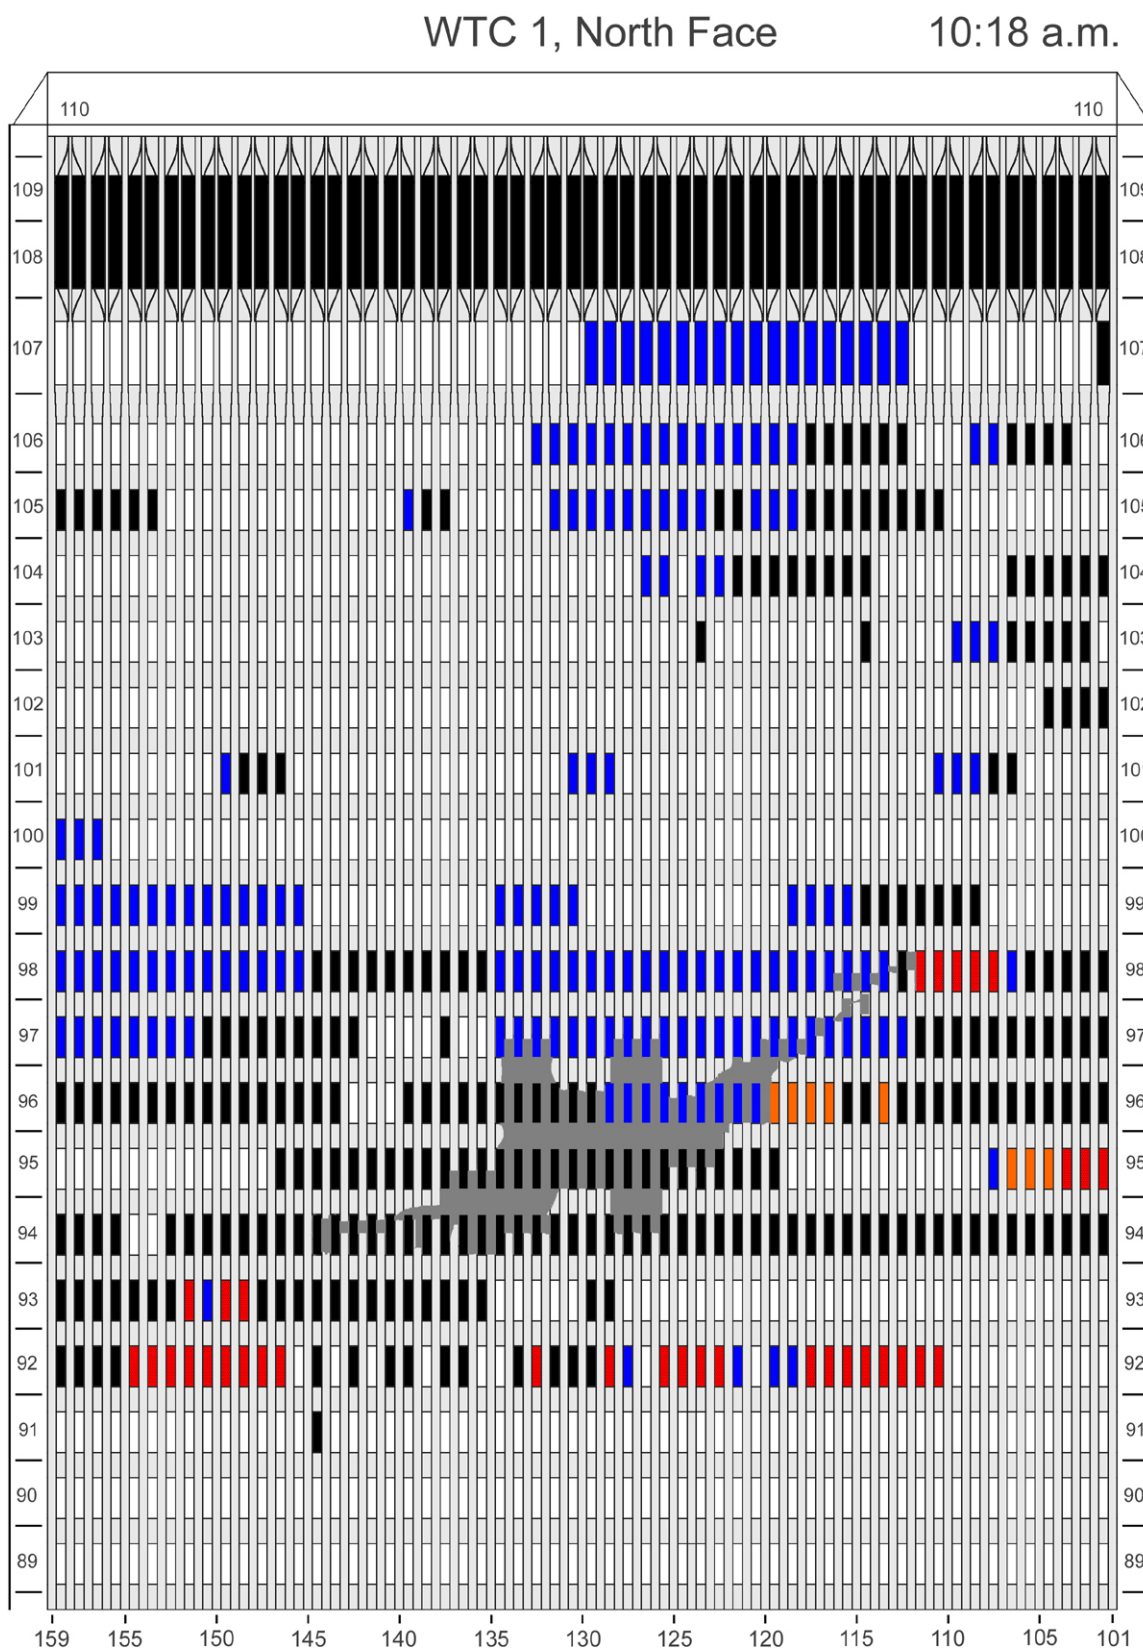
**Figure C-51. Diagram of the north face of WTC 1 for floors 89 to 110 at 10:18 a.m. showing the condition of windows and locations of fires.**

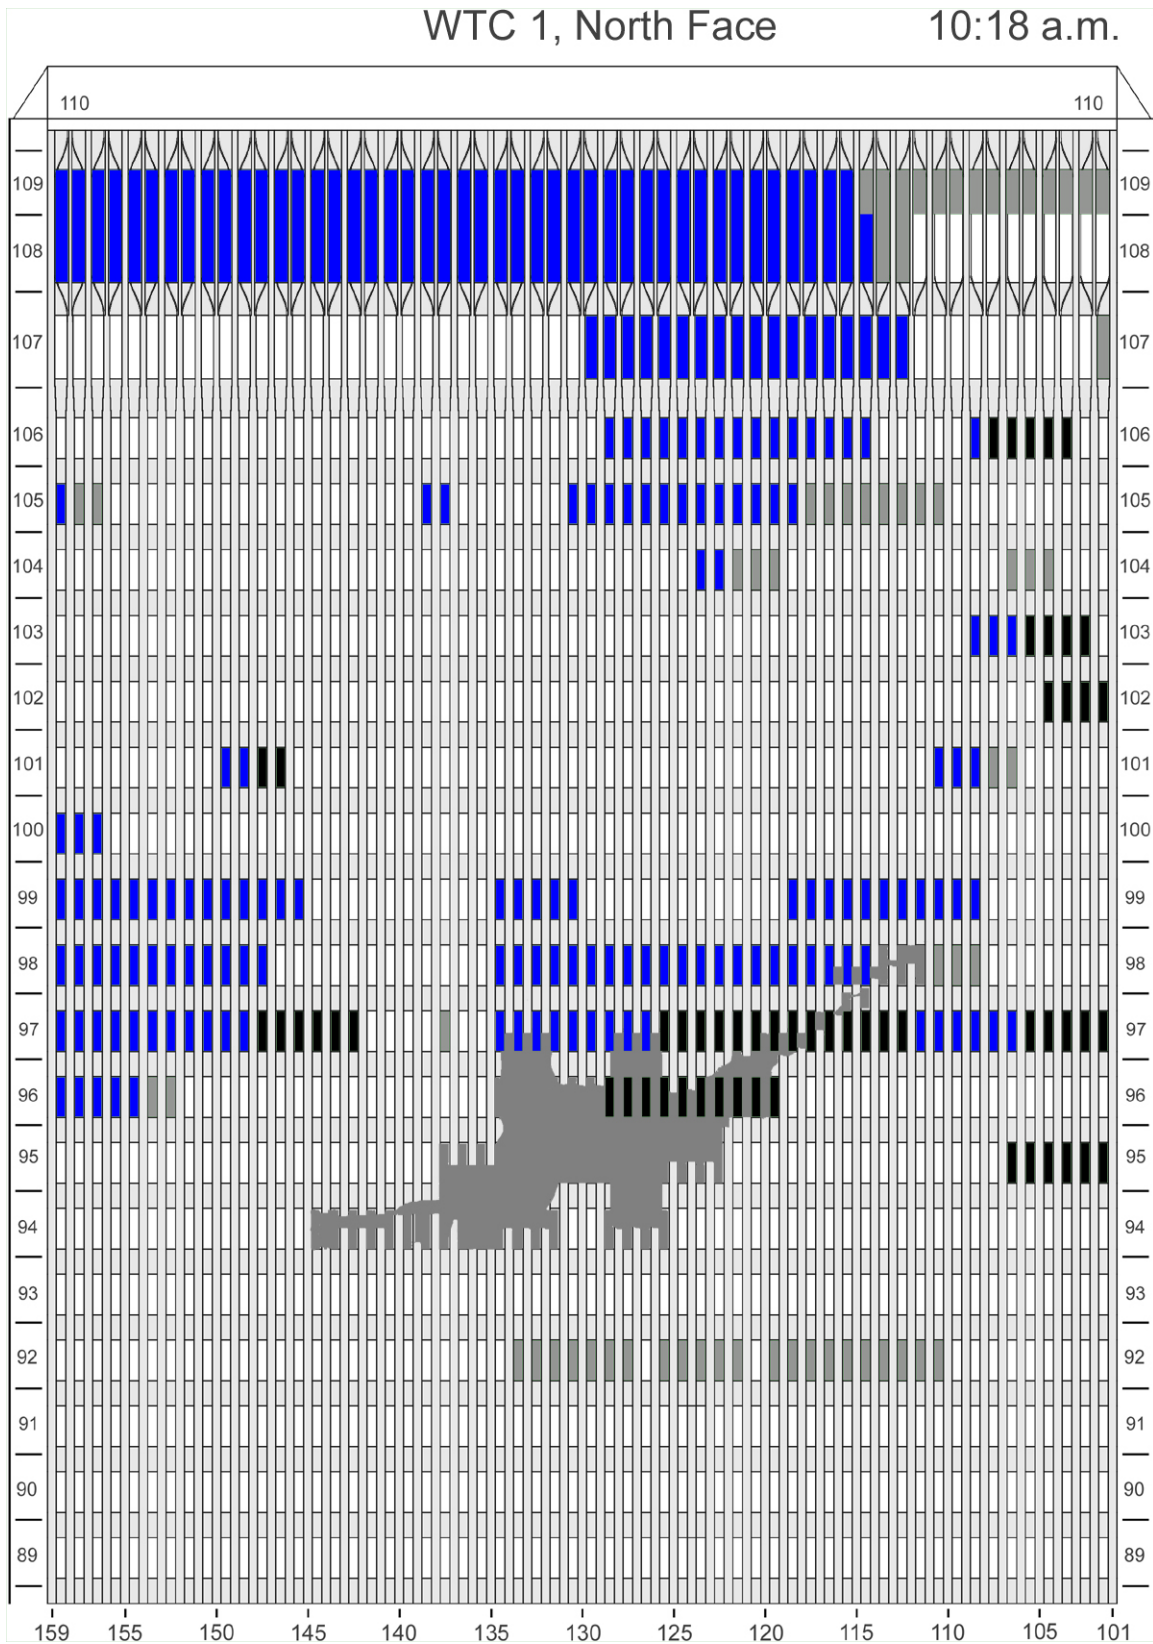
**Figure C-52. Diagram of the north face of WTC 1 for floors 89 to 110 at 10:18 a.m. showing windows where smoke was observed and those that were hidden from view.**

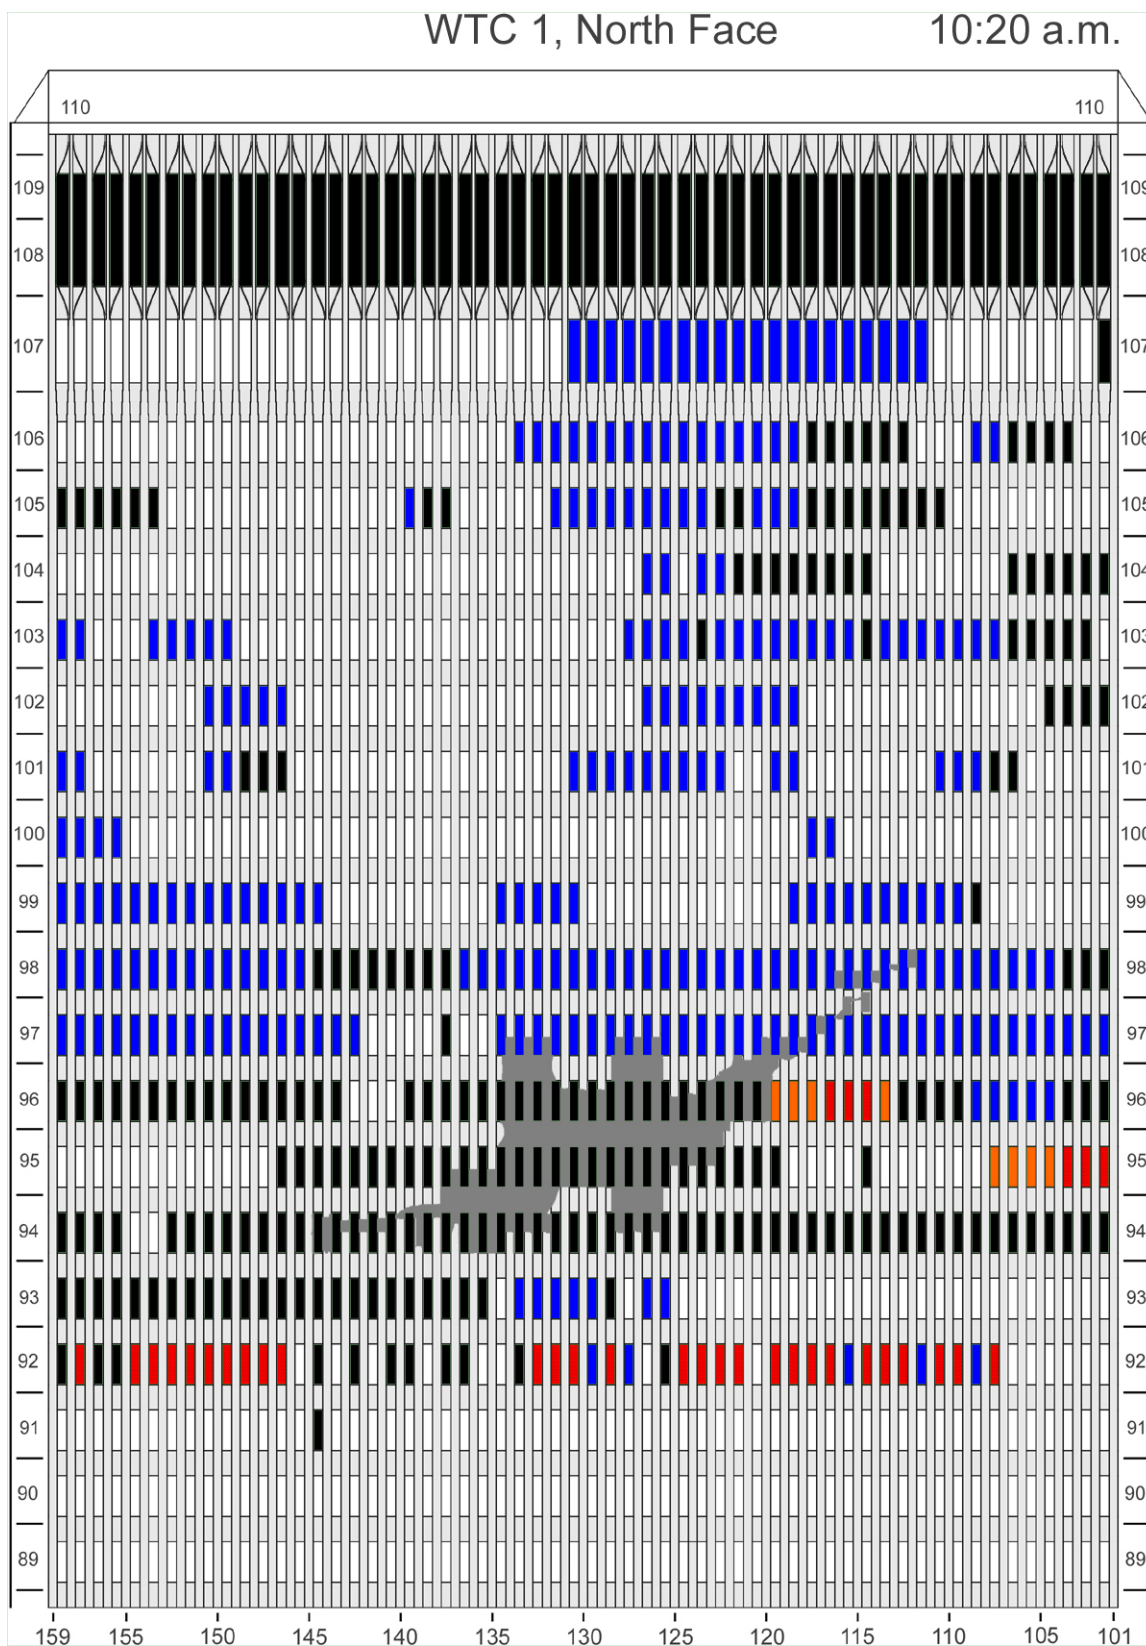
**Figure C-53. Diagram of the north face of WTC 1 for floors 89 to 110 at 10:20 a.m. showing the condition of windows and locations of fires.**

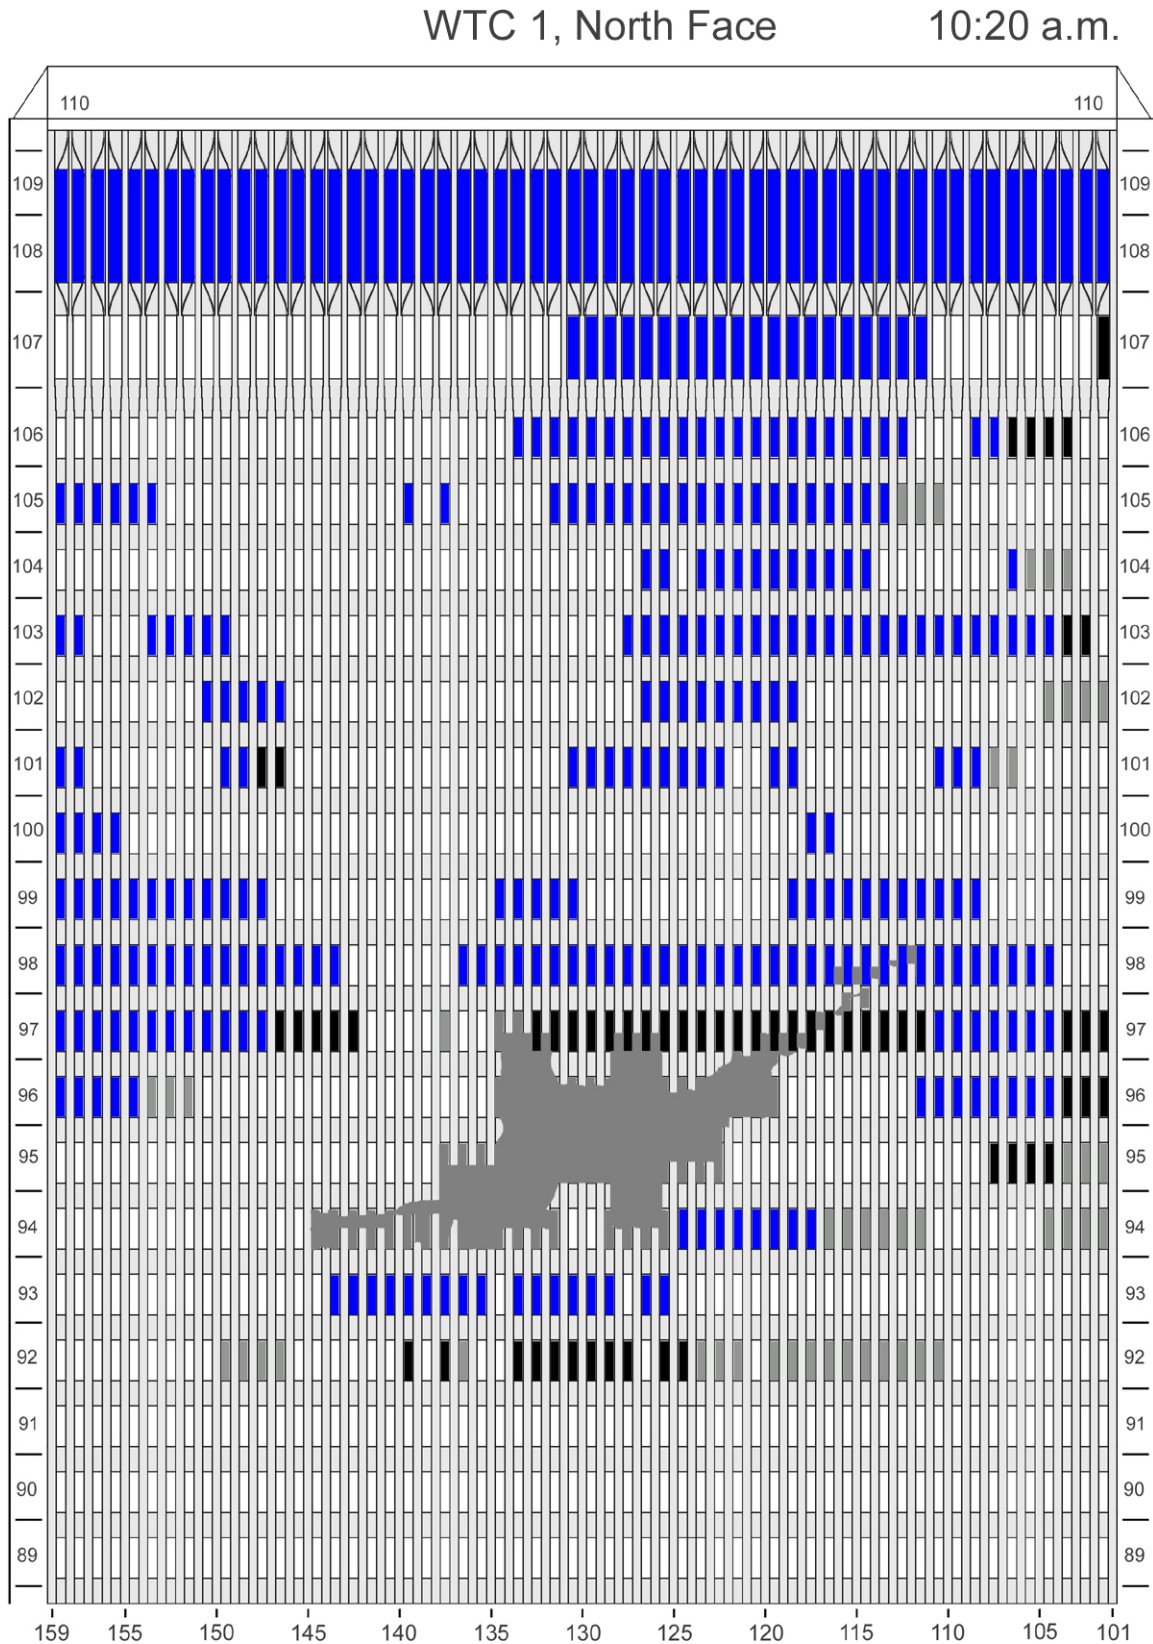
**Figure C-54. Diagram of the north face of WTC 1 for floors 89 to 110 at 10:20 a.m. showing windows where smoke was observed and those that were hidden from view.**
